THE MALDEN SURVEY

A REPORT ON THE CHURCH PLANTS OF
A TYPICAL CITY, SHOWING THE USE
OF THE INTERCHURCH WORLD MOVE-
MENT SCORE CARD AND STANDARDS
FOR RATING CITY CHURCH PLANTS

Copyright 1920 by the
Interchurch World Movement
of North America

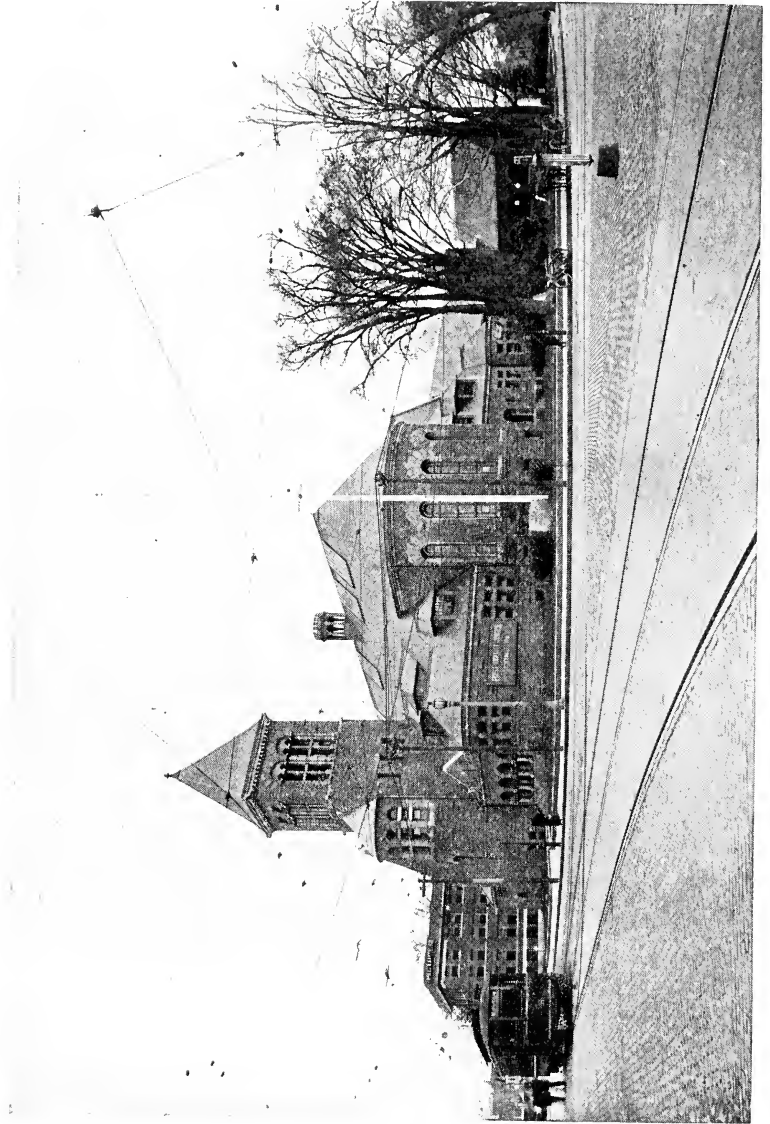
ILLUSTRATION 1. FIRST BAPTIST CHURCH

The score allotted to this church and religious education plant indicates that in many ways it conforms to the standards developed for an ideal plant. The buildings are located at the intersection of two of the main streets of the city and in close proximity to other community buildings such as the public library and the public high school. The buildings would make an attractive addition to any community.

The outstanding features of this plant are the well-planned auditorium, the satisfactory service systems, the large number of high grade and separate classrooms and the exceptionally well-equipped kitchen. The limitations of the site, the unsatisfactory natural lighting of some of the rooms, and the omission of certain community service rooms included in the score card have placed this building in the 700-800 point group. Because the main church is a reconstructed building with the limitations which that puts upon room arrangement and the like, the First Baptist does not receive the perfect score on a number of items. It is the loss of the few points on many items which reduces the total score, and not the failure to provide accommodation for all forms of service.

The general environment of the First Baptist Church is materially heightened by the presence of the public library. This is clearly shown in illustration 1, page 18, which shows the location of the First Baptist plant at one of the most central street intersections in the city. The increased effect which can be secured by planning buildings, which are to serve community needs, in architectural harmony with each other is quite evident in this case. Such proximity causes each building to render the other more imposing without in any way detracting from it. The general neighborhood of the First Parish in Malden Universalist Church is attractive, as is that of St. Paul's, to a certain degree. There are elements of attractiveness in the location of other plants, such as the Mystic Side Congregational and the Robinson Methodist. Illustrations No. 8 and No. 5, pages 32 and 26 show these buildings located in their general environment. There is every evidence that the location of the majority of the seventeen plants was not prompted by visions of extensive community

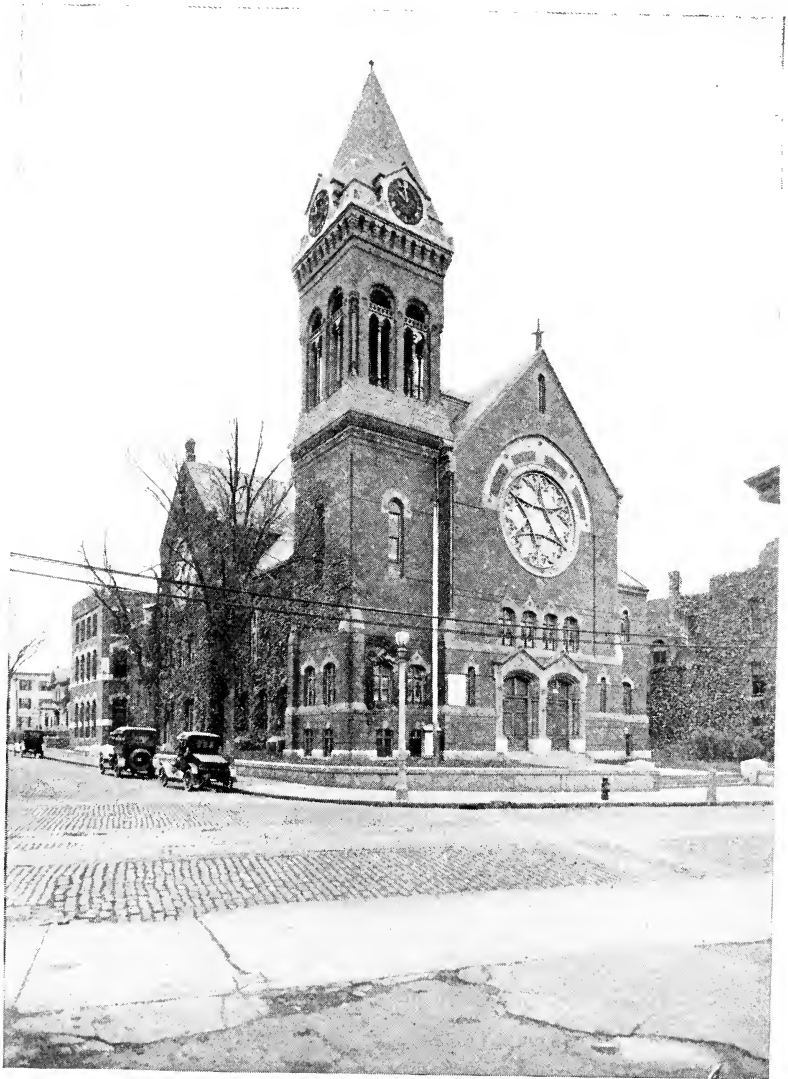
ILLUSTRATION 2. .CENTRE METHODIST CHURCH

The emphasis placed by this church upon a high-grade church auditorium with its desirable equipment and upon a religious school equipment which permits of the segregation of many classes is evidenced in the detail score given these items. The building is located on a corner site with non-fireproof business houses in the immediate neighborhood. The size of the site has necessitated building upward. This has produced a second story auditorium and a three story school building, which should be allowed only in highly fire resistive construction. No out-of-door activities are possible on this site. The location of this downtown church opens great possibilities for community service which cannot be adequately met by the limited existing provisions. The vacuum cleaning and elevator service installations are striking features of this plant.

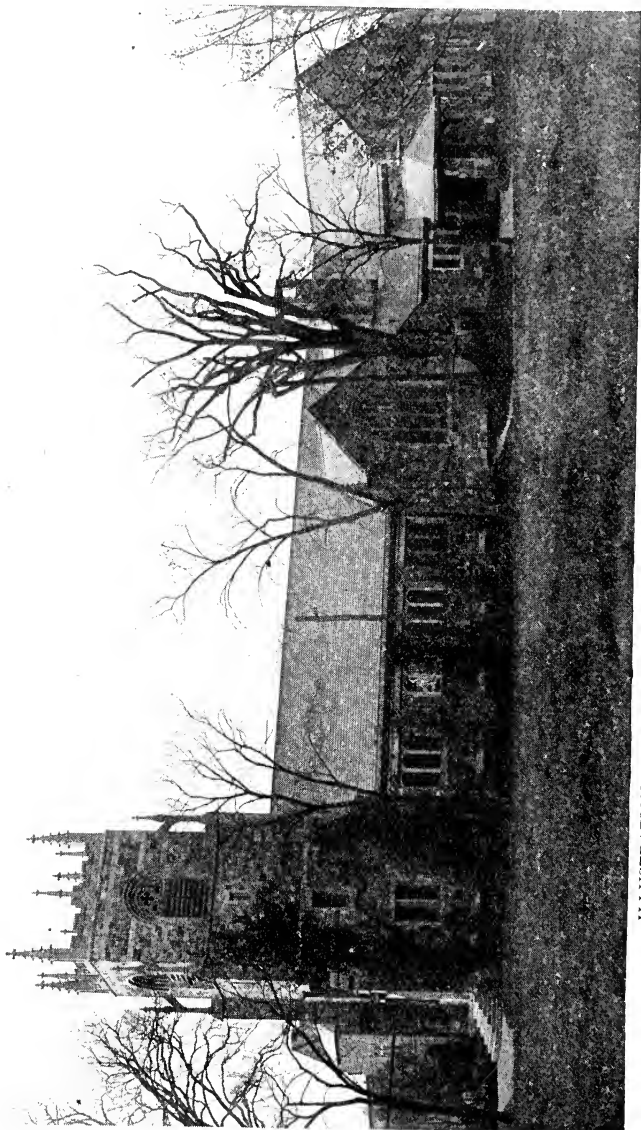
ILLUSTRATION 3. FIRST PARISH IN MALDEN, UNIVERSALIST CHURCH

Conspicuously and pleasingly located on an intersection of streets the First Parish in Malden, Universalist, is one of the most striking and attractive churches in Malden. It is unfortunate from the standpoint of the service which this church should render that so picturesque an exterior should be handicapped by an interior equipment and arrangement inadequate in many respects. A beautiful auditorium is partially spoiled by insufficient light, the corridors are narrow and poorly arranged, the stairways are winding and inadequate, the classrooms are too few in number, poorly lighted and poorly equipped; the service systems are in many cases inadequate, while the element of fire protection has received very little consideration, either in the basement where the furnace is located, or in the ease with which large numbers can get from one part of the building to another. The church has made commendable provision for some forms of special service neglected in many of the other churches in Malden, even though these do not meet the standards set by the score card. Some of these are the pastor's study, recreation room, auditorium with stage, and dining room and kitchen. The convenience of the rooms and the service of the church could be materially increased if several of the rooms were rearranged with this in mind.

The immediate environment of St. Paul's and the plant of the First Parish in Malden, Universalist, as seen in illustrations 4 and 3, pages 24 and 22, shows how much two of the churches are contributing toward beautifying their neighborhood.

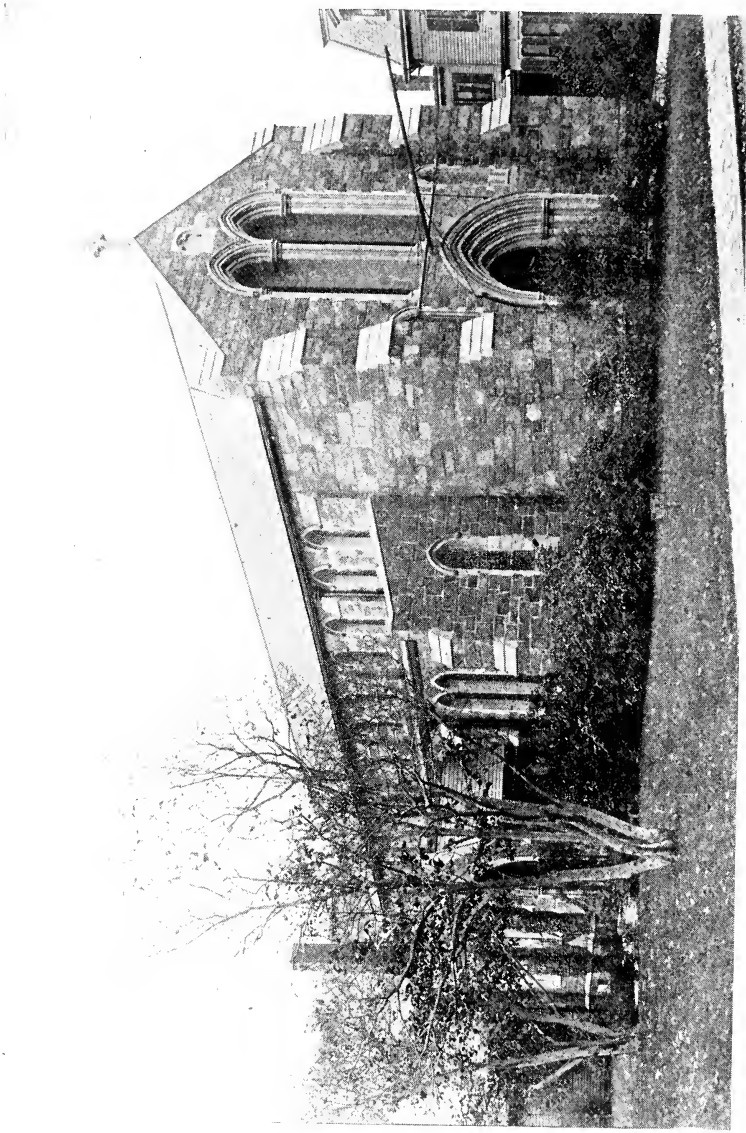
ILLUSTRATION 4. ST. PAUL'S EPISCOPAL CHURCH

If the high standard set in the construction of the new church auditorium section of this plant had prevailed throughout, the score allotted would have been very much higher. This new section accounts for the 112 points on church rooms and for much of the score on Item II. It is hoped that, when the old sections of this plant are replaced by new buildings, the standards of this score card will be used as a guide. There will be a distinct need for additional land if the desirable standards are reached. It has already been recognized by the members of St. Paul's Church that the present school and community provisions are totally inadequate.

The attractive elements in the present situation are the harmonious relationship between the landscape and the new building and the ease of entrance and exit to the new building.

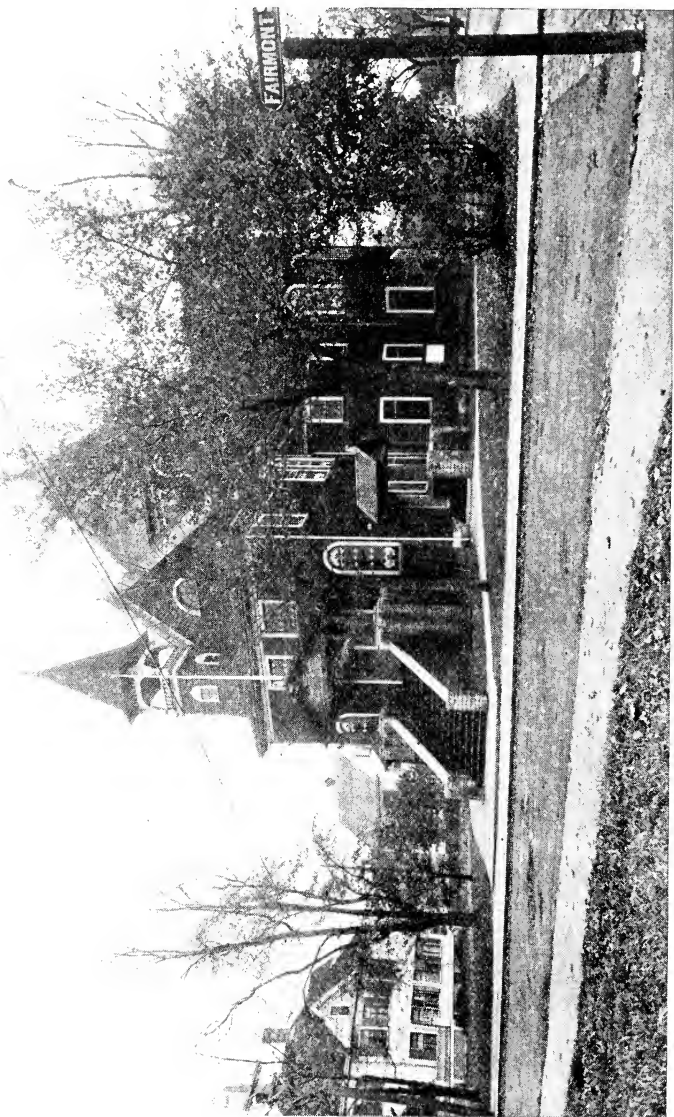
ILLUSTRATION 5. ROBINSON METHODIST CHURCH

The church is unfortunate in its main entrance and in its second story auditorium. The present structure is the result of an addition to an older building. A better plan would have involved discarding the old structure, increasing the size of the site and building a fire-resistive structure which embodied the standards set up by modern needs.

Attractive elements in this situation are the library and the homelike tendency in the rooms of the first floor.

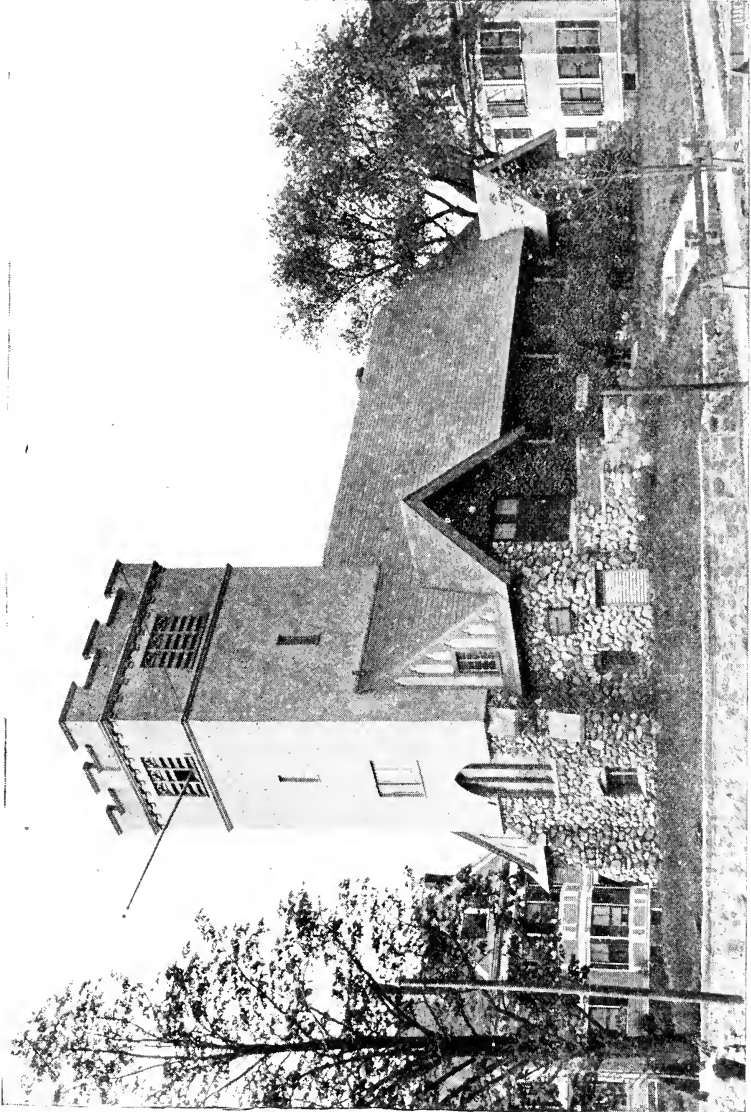
ILLUSTRATION 6. FAULKNER METHODIST CHURCH

This church presents an attractive exterior. Although its construction is recent as compared with that of many of the other Malden plants, there is little evidence of planning for the future in its site, the plan of the building or its equipment.

The site, although much more satisfactory than others, will never suffice for a large community plant, the need for which will arise in this locality. The building lacks to a large degree desirable educational and community service provisions. The attractive elements in the case are the artificial lighting of the auditorium and the pleasing exterior. Little else about the building commends itself for mention.

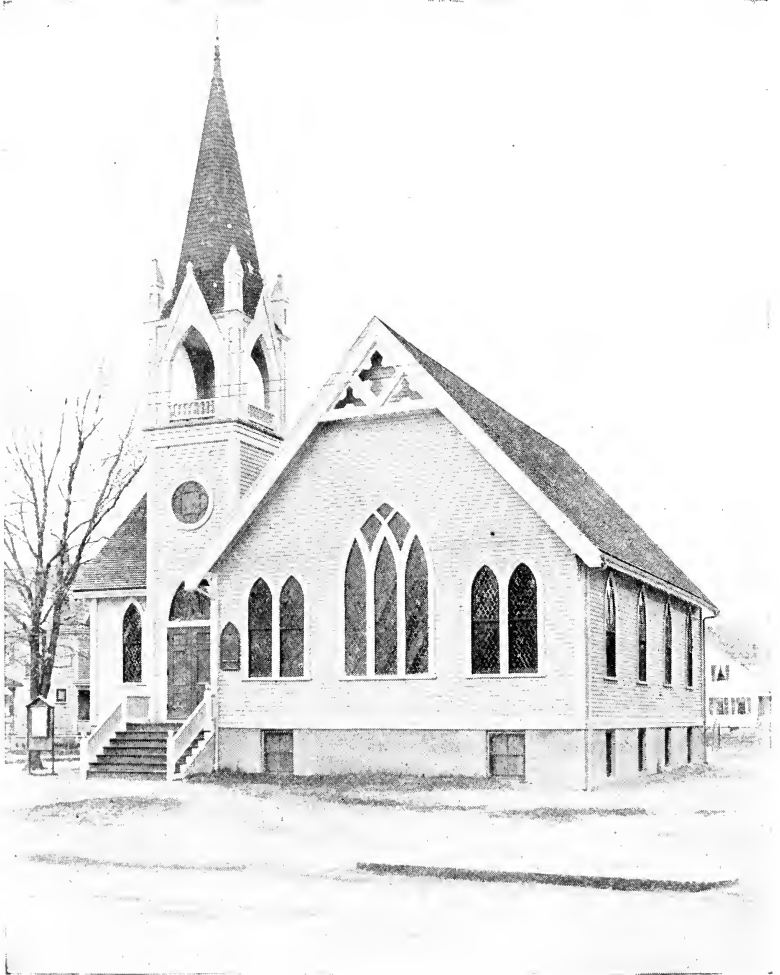
ILLUSTRATION 7. LINDEN METHODIST CHURCH

This building was scrupulously clean throughout. Its equipment was simple, yet well cared for. Its ornamentation was inexpensive yet attractive and gave evidence of much thought.

No doubt, although the site is small, the service systems limited, and auxiliary rooms few in number, the plant is, in many respects, efficiently serving its patrons.

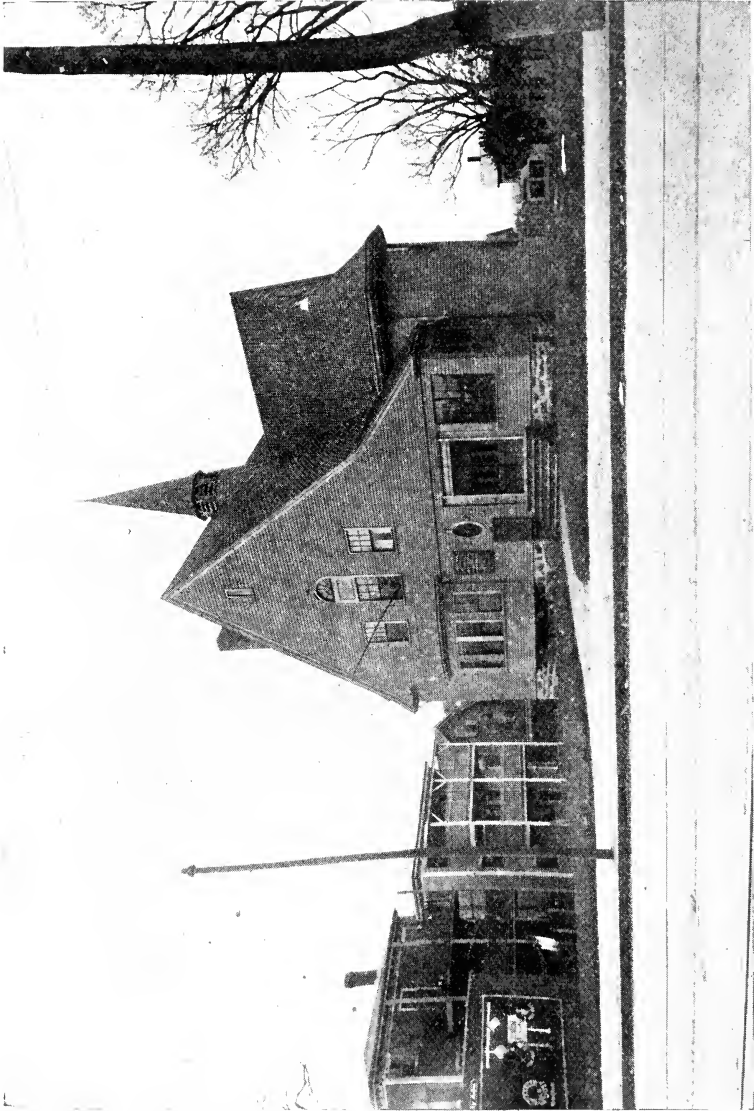
ILLUSTRATION 8. MYSTIC SIDE CONGREGATIONAL CHURCH

This church falls in the 350-400 point group. The outstanding features of the plant are the relatively large site, the attractive front classroom and the businesslike pastor's study.

The congregation has outgrown this plant and has already planned to build a new structure. It is hoped that the faults of the old building will be eliminated in the new. In this building the fire danger is ever present, the kitchen facilities are very poor, the toilets fail to reach a satisfactory standard, storerooms are inadequate, the lighting system is defective, the kindergarten room unfortunately placed and many desirable features are lacking entirely.

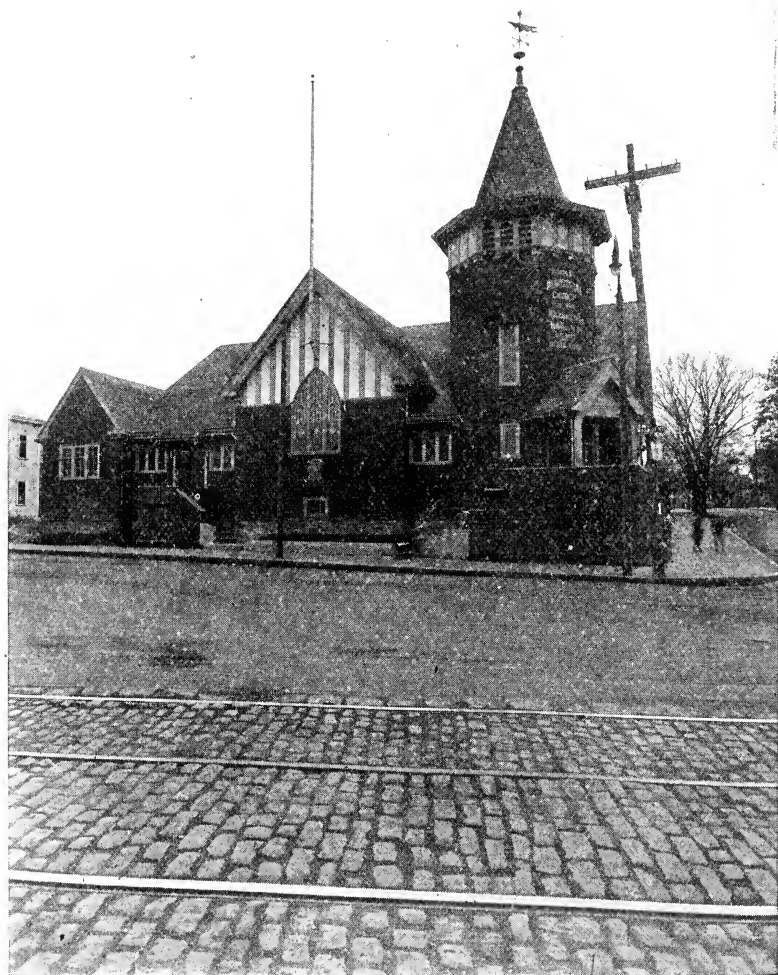
ILLUSTRATION 9. PEOPLE'S PENTECOSTAL CHURCH OF THE NAZARENE

This church is well located on a corner lot and so orientated as to command the best possible lighting. It is a relatively new structure but of a construction more typical of residences than of churches. The site is so small that the church almost stands on the sidewalk. The interior of the church is very attractive, with plain walls, well-harmonized woodwork, artistic and efficient indirect lights and new and well-kept furniture. The general effect is somewhat spoiled by some large water stains on the walls resulting from leaks, which in turn were results of light construction. The basement is very small, extremely low and entirely exposed to fire risks from the furnaces. The provision for religious education rooms is convenient as an enlargement of the auditorium, but neither well-arranged nor adequate for graded instruction. The fact that the pastor's home is attached to the church makes it possible for him to be directly in touch with the work of the church. The score of this church is lower than it otherwise would be because of the entire absence of all rooms for community service—a provision which the church does not believe in making.

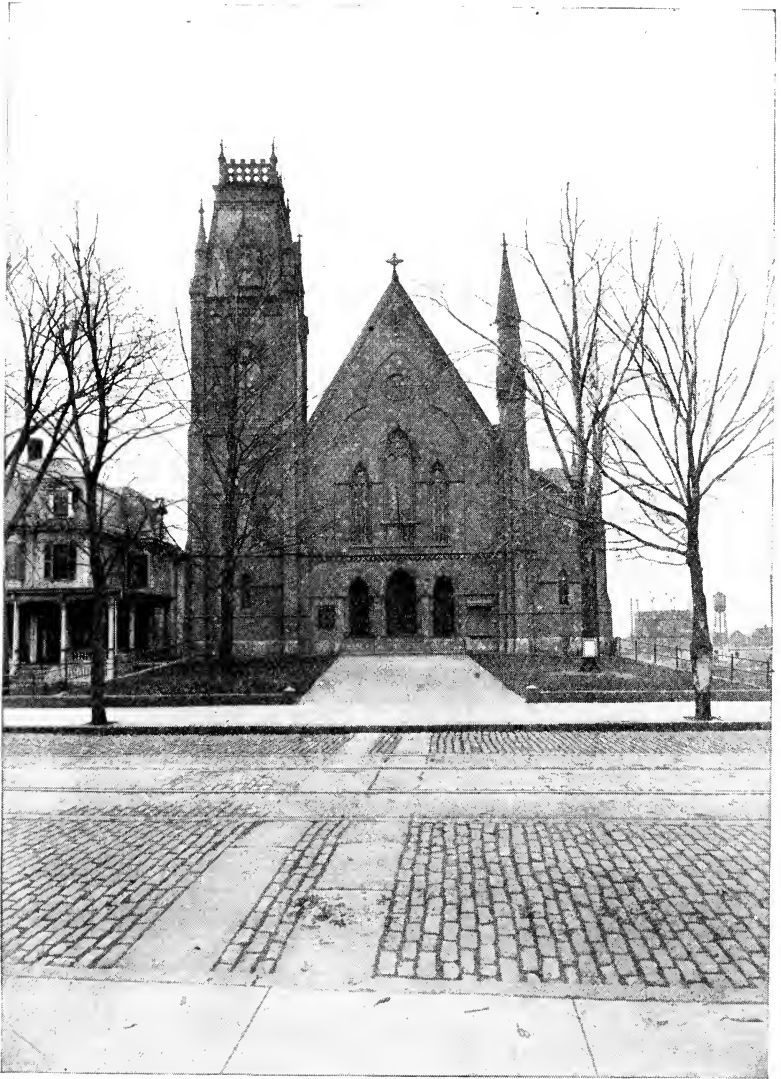
ILLUSTRATION 10. FIRST TRINITARIAN CONGREGATIONAL CHURCH

Constructed long before the extensive community service suggested by the score card standards was required of churches, this plant is found deficient in many particulars. The maintenance of this building has been high-grade with the exception of the basement. Its location was at one time much more desirable than today. The environment indicates that the church is gradually being crowded out by industrial and commercial developments.

The largest number of points has been allotted this building in its church rooms, especially its auditorium. The almost total lack of classrooms, the limitations of the community service rooms and its non-standard service systems account for much of the low score.

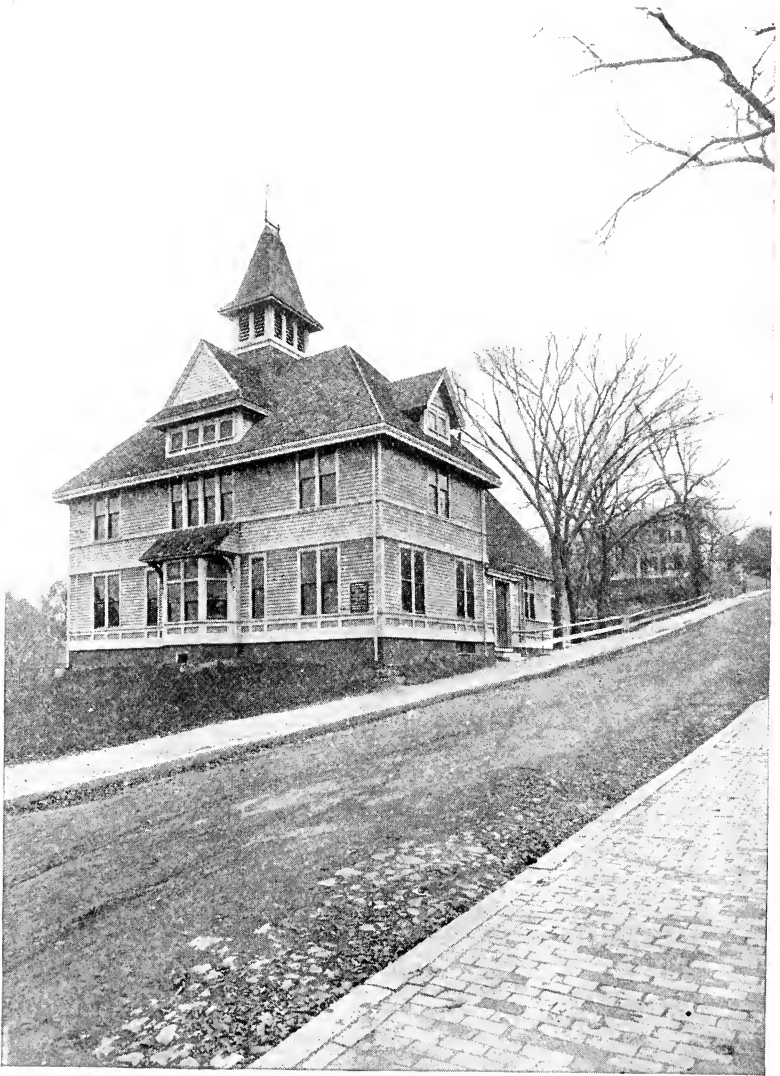
ILLUSTRATION 11. EASTERN AVENUE BAPTIST CHURCH

This church has little to recommend it to the passerby. Its site is undesirable and the building in many ways does not even resemble a church. Its interior, however, is commendable in many respects, which accounts for its receiving a higher score than would appear warranted from an outside view. The building is scrupulously clean even to the basement, the decoration of walls and ceiling is recent, harmonious and attractive and the service systems, while far from standard, are efficient and in a good state of upkeep. The congregation has given most of its attention to the efficiency of its church rooms which receive a relatively high score. In addition to the main auditorium, provision has also been made for a small assembly room which can also serve for church board meetings, for a special room equipped for communion services, for a pastor's study and for a church office.

When the plans that are now being discussed for finishing the basement and making adequate provision for preparation rooms for baptismal ceremonies are made actualities, this church will find its opportunities much increased and will be approaching a maximum use of a poor building.

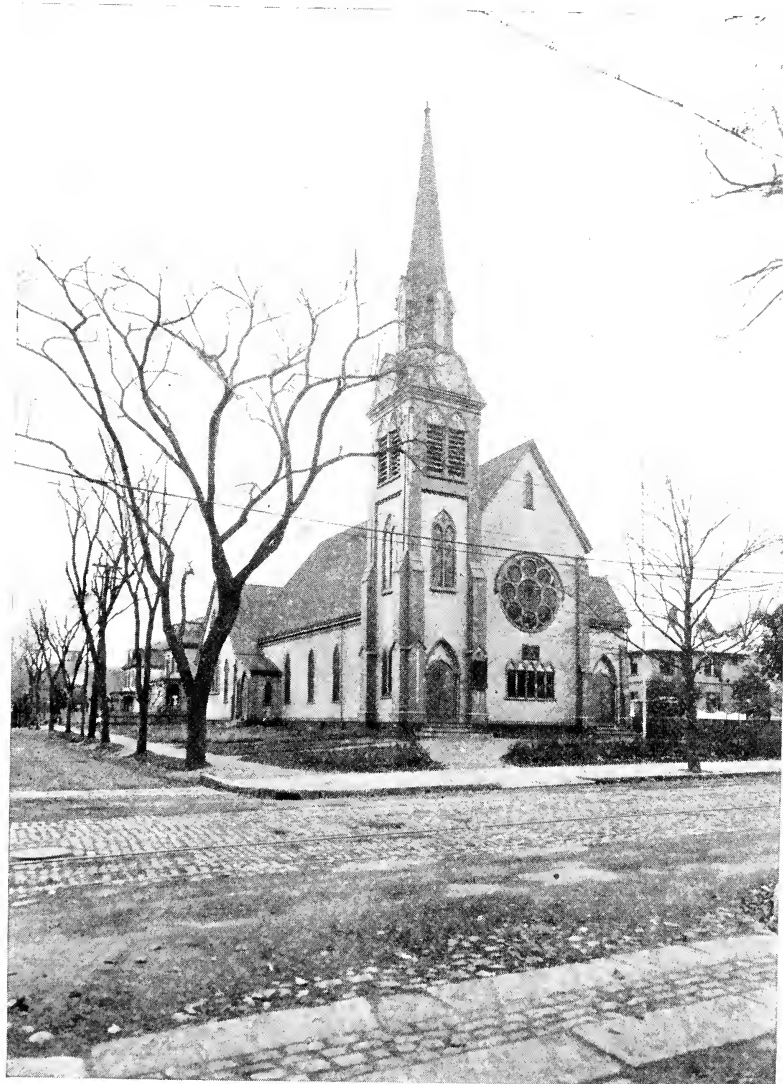
ILLUSTRATION 12. MAPLEWOOD BAPTIST CHURCH

The church is used for some community activities now, though its equipment for this form of service is very inadequate and in a discouragingly poor condition. A church library is provided though it has the appearance of being seldom used. It would be possible greatly to increase the community service of this present plant, although no amount of remodelling would make it approach the standards for the various items.

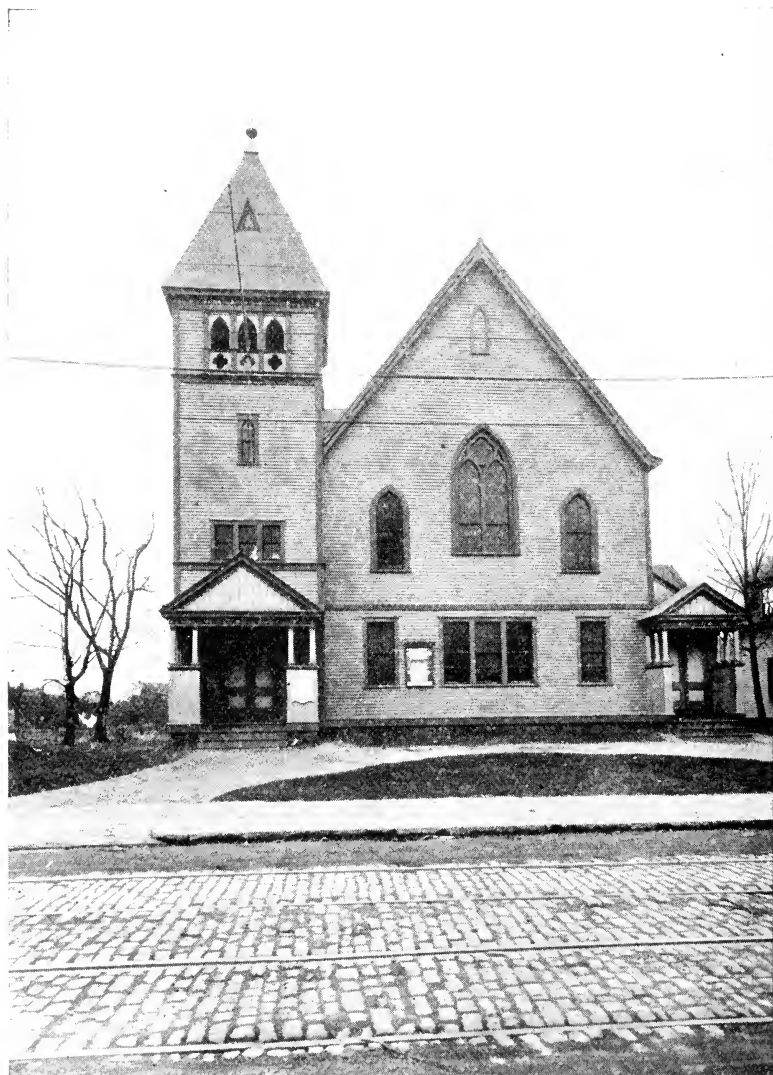
ILLUSTRATION 14. MAPLEWOOD METHODIST CHURCH

The building is old and poorly arranged. The rooms used for religious instruction are well grouped although they are inconvenient of access and poorly furnished. The service systems—heating, lighting, toilet, water supply and fire protection are among the poorest in all of the churches in the city. As in many of the smaller churches, the auditorium is the most commendable room of the church, but this one is made less so by being on the second floor and provided with very inadequate stairways. Almost no effort has been made to do any form of community service other than the traditional, distinctly religious forms. The present church plant would seriously lessen the chances of success for any such program.

This is another church which reaches about one-third of its possible efficiency as shown by its total score. For reasons previously given, probably it would better be abandoned in order that its congregation might join forces with some larger, better equipped church.

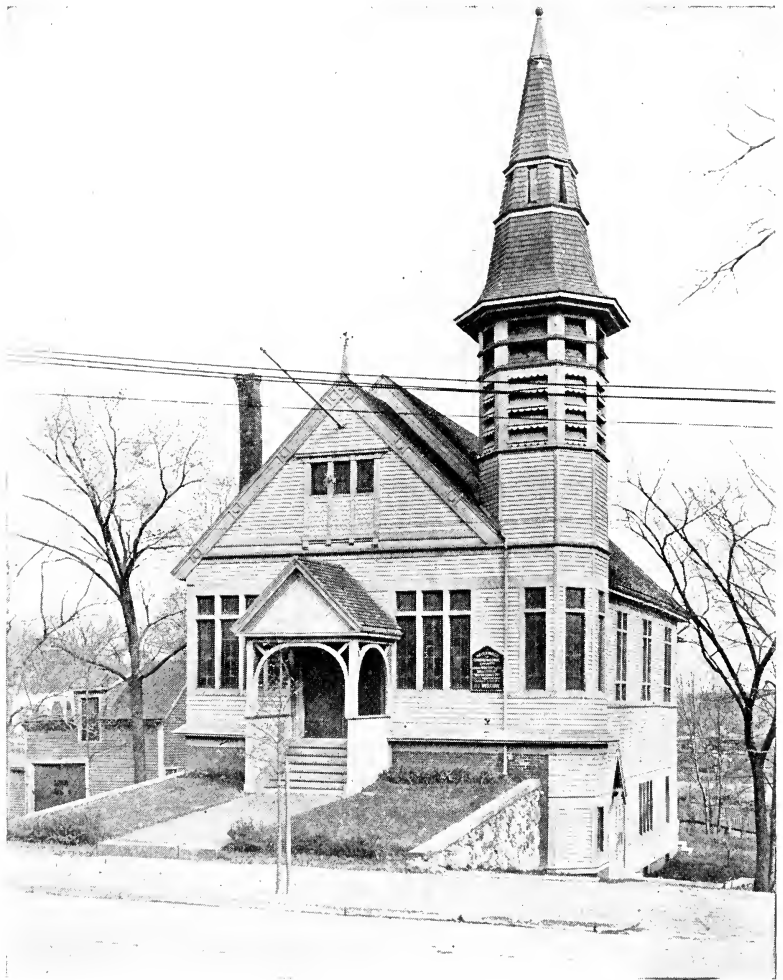
ILLUSTRATION 15. MAPLEWOOD CONGREGATIONAL CHURCH

This frame church is built on a site inadequate for any other purpose than the location of a building. The site is on such a steep slope that it prevents the use of any part of it or of nearby ground if acquired for any service. Landscape effects are almost impossible and the low, swampy land at the rear of the site prevents any expansion in that direction. The main elements in this situation are a church auditorium, rather severe but well maintained and a school assembly room about which there is little semblance of modernity. With limited equipment, a paucity of classrooms and almost no suitable service rooms, this plant can render only in slight degree the community service which might be possible.

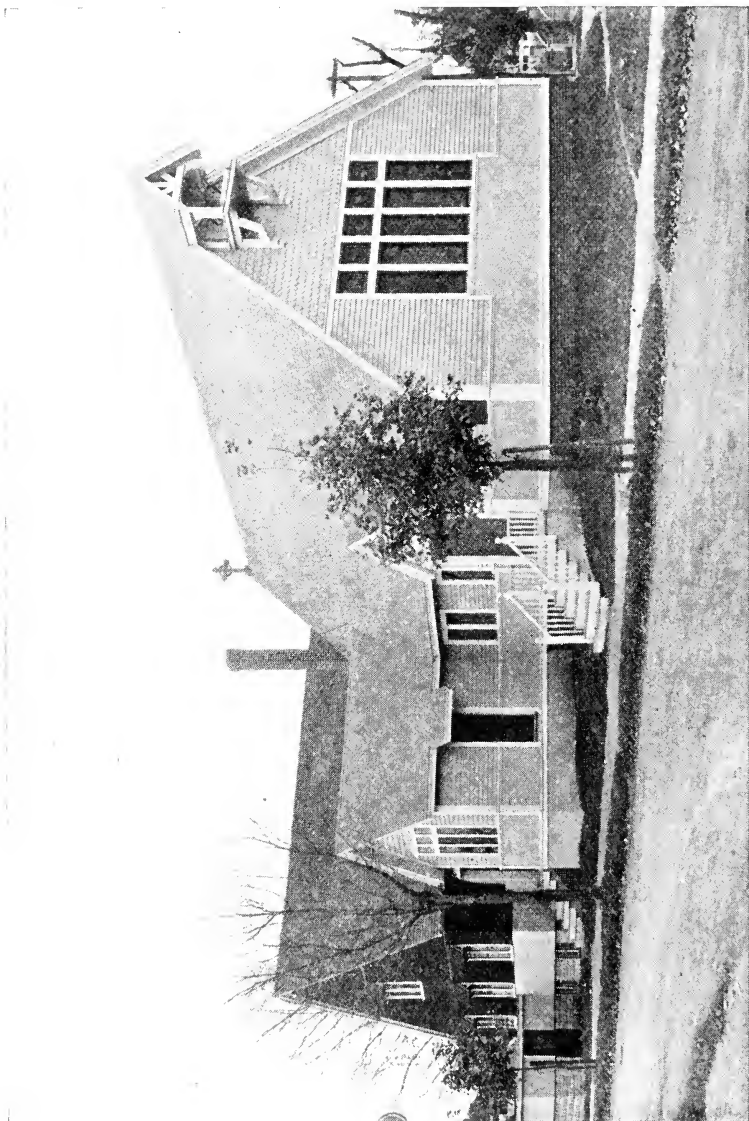
ILLUSTRATION 16. ST. LUKE'S EPISCOPAL CHURCH

Although this church is located in one of the less densely settled sections of Malden, its buildings cover a very large part of its site. The Linden section of Malden cannot adequately support three or four large community service church and religious education plants. The inadequate plants which exist there today are evidence of this fact. A cooperative community spirit should produce one large community house for this section. Such a plan need not interfere with differences in forms of worship but could assure religious education for the children and service for adults far beyond what has been found possible in the existing churches.

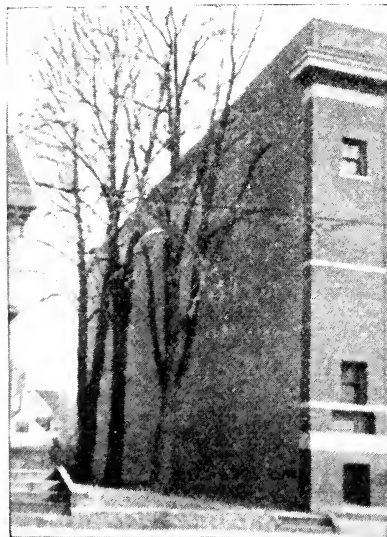
ILLUSTRATION 20. BLANK WALL OF PARISH HOUSE, FIRST BAPTIST CHURCH. THIS PREVENTS ADEQUATE LIGHTING OF LARGE ROOMS

Perhaps the most outstanding result of the effect of an inadequate site in a particular situation is that evident from study of illustration 22 and 20, pages 59 and 57. The religious school building of the First Baptist plant presents an attractive appearance from the church side. The site, however, is so small that it was considered necessary to build this structure with one side close to the neighboring property line. The building, on this side, has been given a blank wall, thereby detracting to a considerable degree from its beauty both within and without and from the advantages that accrue from good natural lighting of classrooms. A school building of this size requires a site sufficiently large for play and pageantry purposes.

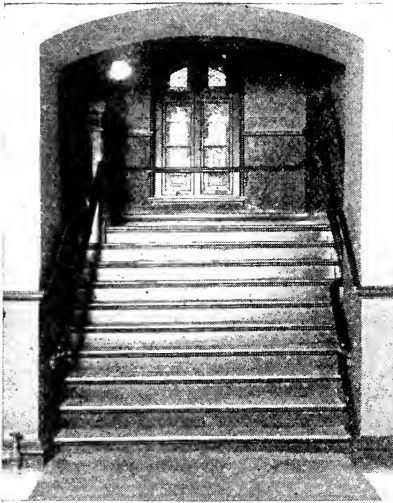
ILLUSTRATION 25. ONE OF TWO MAIN STAIRWAYS FROM THE LARGE AUDITORIUM OF THE CENTRE METHODIST CHURCH

Illustrations 25 and 26, page 65 show two of the three main stairway exits for the large Centre Methodist auditorium. The front stairways are not provided with adequate natural light. These stairways are not well conceived for the passage of large groups from the auditorium and balcony floors. The rear stairway requires an additional turn at the bottom before the exit doors can be reached. This makes a total of four turns which must be made by a group descending from the second floor to the side entrance. The standard that no storerooms be placed under the stairways unless fireproof is violated in the case of these two stairways.

could reach safety. It is unfortunate that this auditorium has been located as it is. The close proximity of other non-fireproof buildings, the non-fireproof nature of the Centre Methodist structure and the wooden construction of its stairways, as shown in illustrations 25 and 26, page 65, make further precautions for safety quite necessary. Other elements adding to the dangers are the store rooms, and other rooms under the stairways and the fact that the balcony with its seating capacity of 350 to 400 may be considered as being on the third floor.

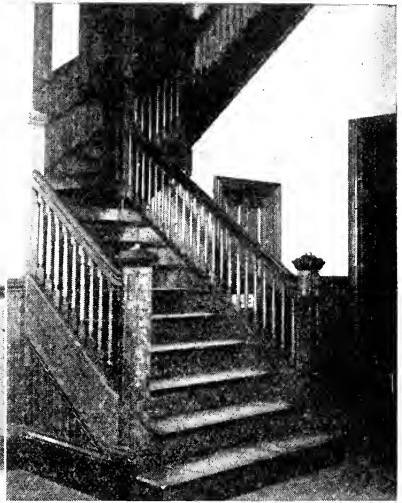
ILLUSTRATION 26. A WOODEN STAIRWAY OF QUESTIONABLE VALUE IN TIME OF DANGER. CENTRE METHODIST CHURCH

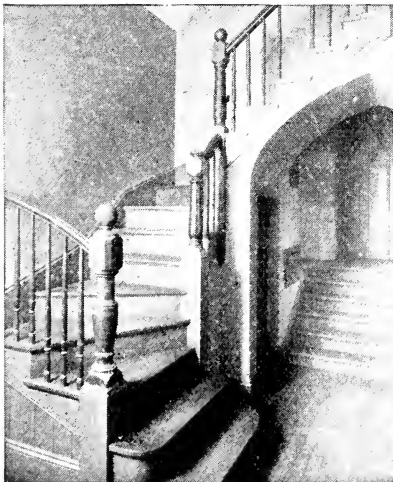
ILLUSTRATION 27. DANGEROUS WINDING STAIRS FOR PRIMARY CHILDREN. ST. PAUL'S EPISCOPAL CHURCH

Illustrations 27 and 28, page 65, of stairways, Maplewood Baptist and St. Paul's plants respectively, are other types of stairways to be found in the seventeen plants. The first stairway is narrow, without handrails and artificial light, doubles back on itself and is located directly over a stairway leading to the littered cellar of illustration 43, page 80. The second stairway is a winder of a very bad type, and lacks handrails and sufficient artificial light. It leads to a classroom where

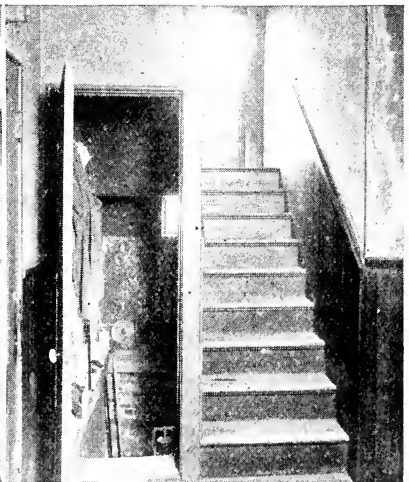
ILLUSTRATION 28. A PROBABLE DEATH TRAP IN CASE OF FIRE. MAPLEWOOD BAPTIST CHURCH

Illustrations 43, page 80, 28, page 65, and 54, page 99, confirm the necessity for this standard. These three pictures lead from a most disreputable basement with every possible fire danger lurking about, to the equally dangerous store room adjoining a class room and located under the partially concealed roof rafters. To be sure, conditions shown in these pictures ought not to be tolerated in any church. Fireproof construction would, on the other hand, ward off the possible results of such disregard for the safety of human beings.

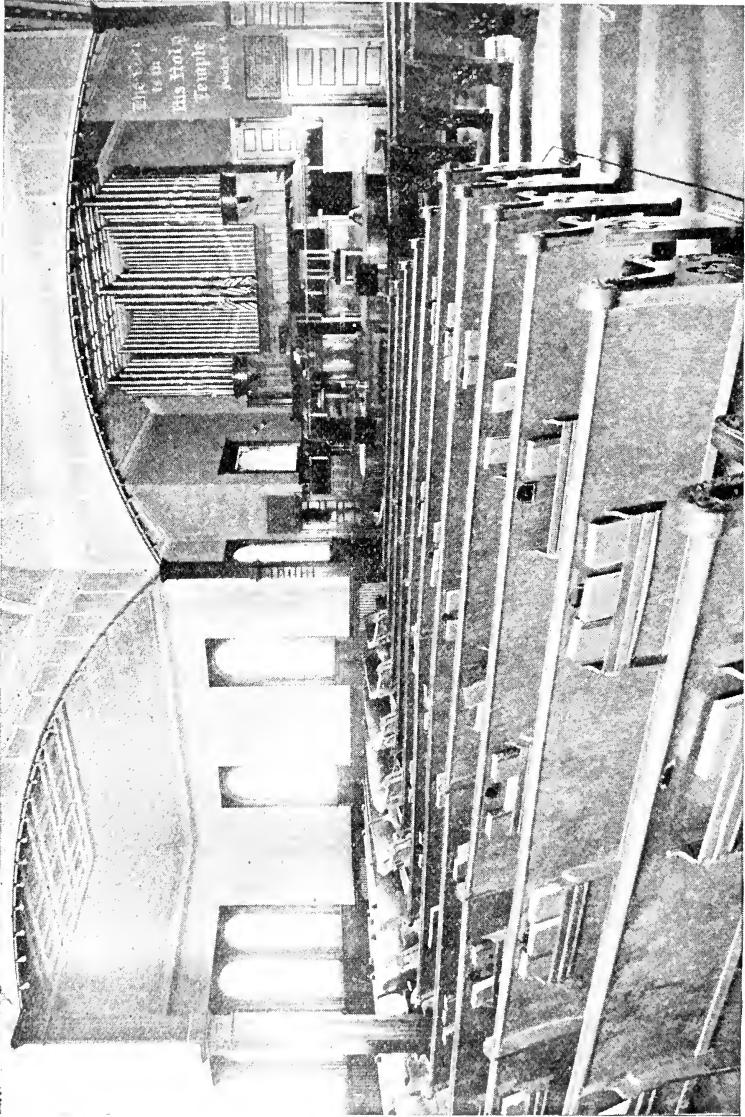
ILLUSTRATION 29 THE SECOND STORY AUDITORIUM, ROBINSON METHODIST CHURCH, THE ONLY EXIT FROM WHICH APPEARS IN ILLUSTRATION 31

The "second story" auditorium of the Robinson Methodist presents nearly equal possibilities for disaster. The exterior view of the Robinson Methodist in illustration 5, shows the steep ascent from the ground level to the first floor. A second steep broad stairway without adequate handrails runs from the first floor as shown in illustration 31, page 67, to the floor of the auditorium shown in illustration 29, page 66. The extreme width of this church auditorium would add to the danger in case of fire. The careless storage of old shingles and other materials in such a manner as to increase the fire danger was noticed in this basement.

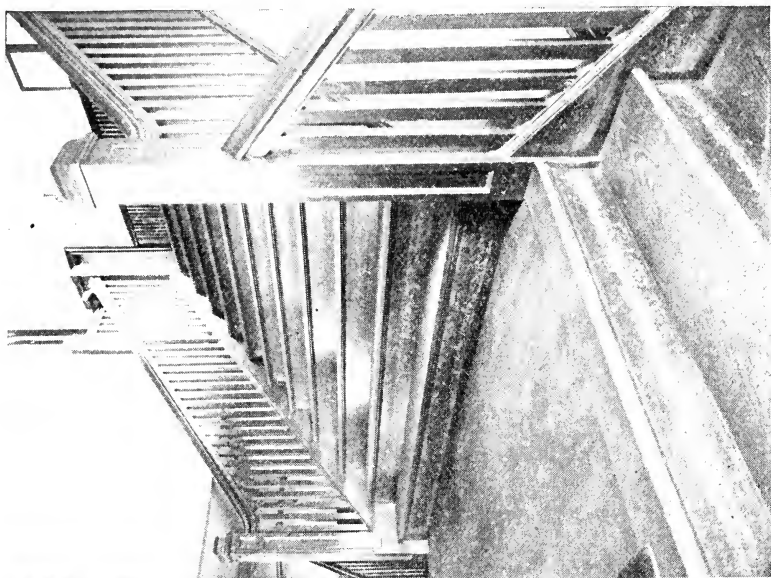
ILLUSTRATION 31. BY ADDING THIS STAIRWAY TO THAT OF ILLUSTRATION 30 ONE MAY VISUALIZE THE ONLY APPROACH TO THE ROBINSON METHODIST AUDITORIUM

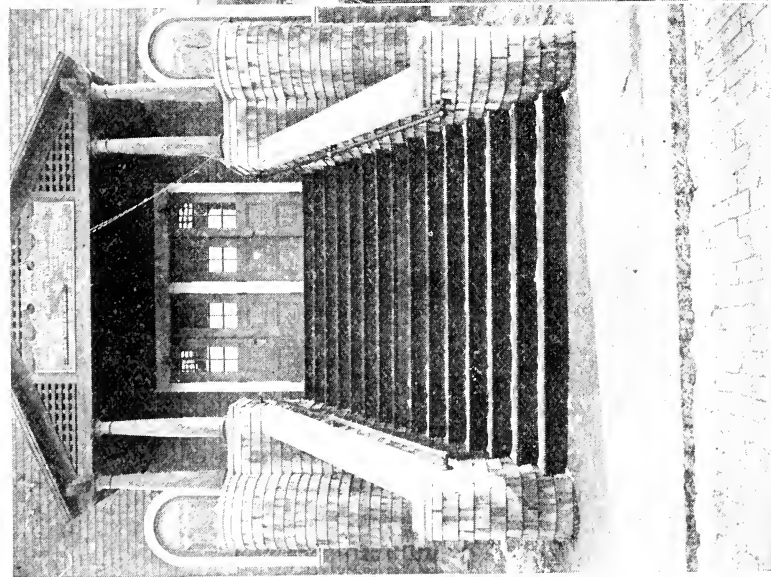
ILLUSTRATION 30. THE FIFTEEN TREAD STEEP FRONT STAIRWAY OF THE ROBINSON METHODIST CHURCH

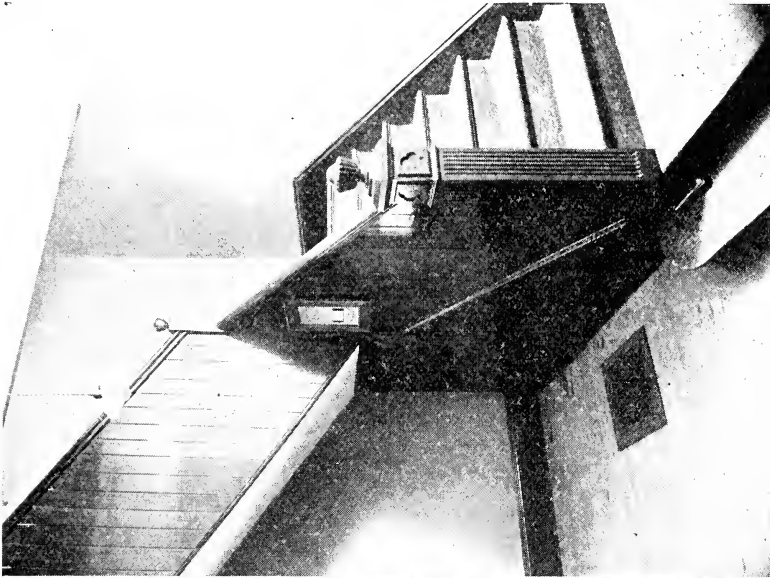
ILLUSTRATION 34. THE UNPROTECTED FRONT STAIRWAY LEADING FROM THE AUDITORIUM SHOWN ON OPPOSITE PAGE

Illustration 34, page 71, reproduces the single main stairway which is used for exit from the auditorium of the Maplewood Methodist Church (see illustration 32, page 70). The secondary stairway to the rear of this auditorium is not superior to the type shown in illustration 36, page 74. This main stairway is of wood, lacks handrails has three turns and is inadequately provided with artificial light.

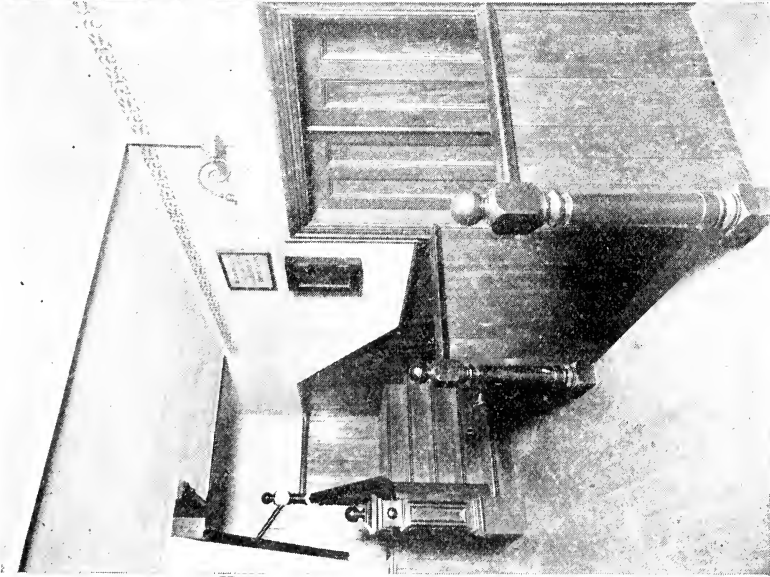
ILLUSTRATION 33. ONE OF TWO VERY POORLY CONCEIVED STAIRWAYS TO THE MAIN AUDITORIUM OF THE LINDEN CONGREGATIONAL CHURCH

Illustration 33, page 71, presents the highly unsatisfactory stairways of the Linden Congregational Church. Each of two stairways to the auditorium on the second floor is so narrow as to be easily congested and has three flights, with two turns. At the foot of the bottom flight, the passageway is partially blocked by the guards to the stairway entrance of the school assembly room on the first floor. Illustration 35, page 72, shows this entrance into the assembly room with the main entrance doors beyond. Since the auxiliary stairway to the rear of this building is entirely inadequate, it is difficult to conceive of a situation which presents greater hazards.

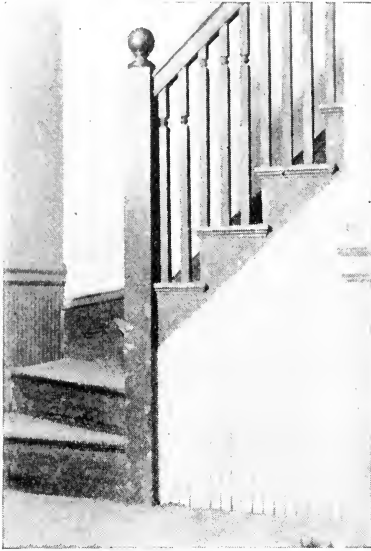
ILLUSTRATION 36. SEE TEXT ON
THIS PAGE

Illustration 36, on this page, shows the only stairway leading from the church auditorium floor to the large assembly room of the basement of the Faulkner Methodist. This stairway is steep, lacks a handrail and has the faulty triangular treads.

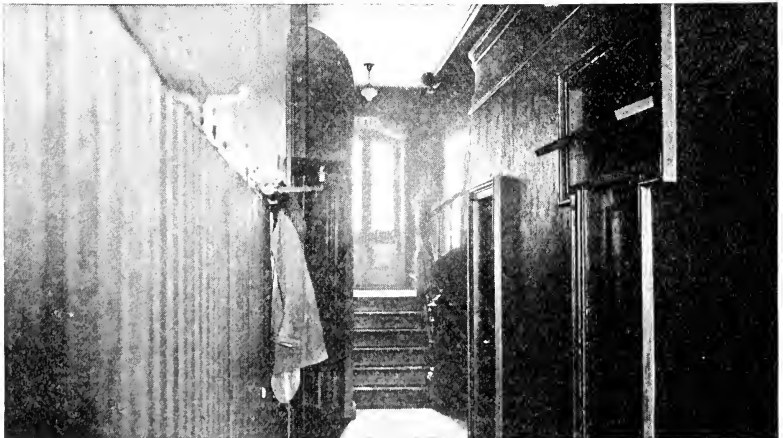
ILLUSTRATION 37. SHOWING THE APPROACH FROM CHURCH AUDITORIUM
TO THE SCHOOL ASSEMBLY ROOM OF THE FIRST CONGREGATIONAL CHURCH

The two winding stairways of the First Congregational Church, of which one is shown in illustration 37, page 74, are very defective types of communication between the two main floors of a church structure.

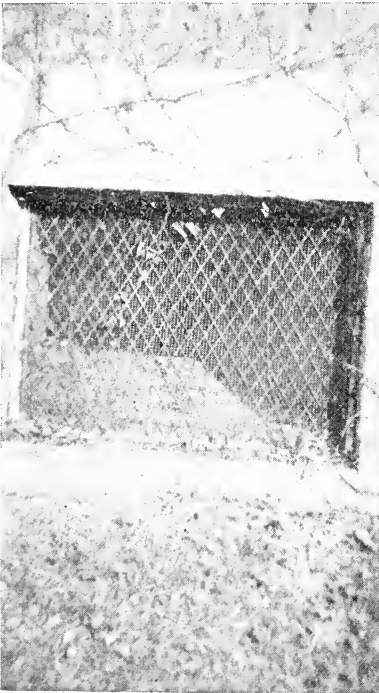
ILLUSTRATION 47. AIR INTAKE OF THE UNIVERSALIST CHURCH, LOCATED AT GROUND LEVEL

One of the most important standards under this heading concerns the source of fresh air supplied. The standards suggest the following: "The fresh air supply for ventilation should be taken from an uncontaminated source, preferably from above the roof, or at a point at least fifteen feet above the grade level. The air supplied should be free from dust and other impurities."

Illustrations 47, 48 and 49, pages 90 and 91, point out the prevailing arrangement for securing fresh air in the churches which have made provisions for fresh air supply. Such intakes, even though screened, cannot be as desirable as those located sufficiently high above ground level, and cannot prevent the entry of small dirt particles or dust and filth blown directly from sidewalk or alley. Air drawn from ground levels should be filtered or washed. All heated air should be properly humidified before entering large audience rooms. These provisions are expensive and yet are found possible in large plants. It should be borne in mind that a hot, dry air may be the cause of colds and sore throats for a surprisingly large proportion of an audience.
